Performance of Horizontal Infrastructure in Christchurch City through the 2010-2011 Canterbury Earthquake Sequence

March 2014

Summary

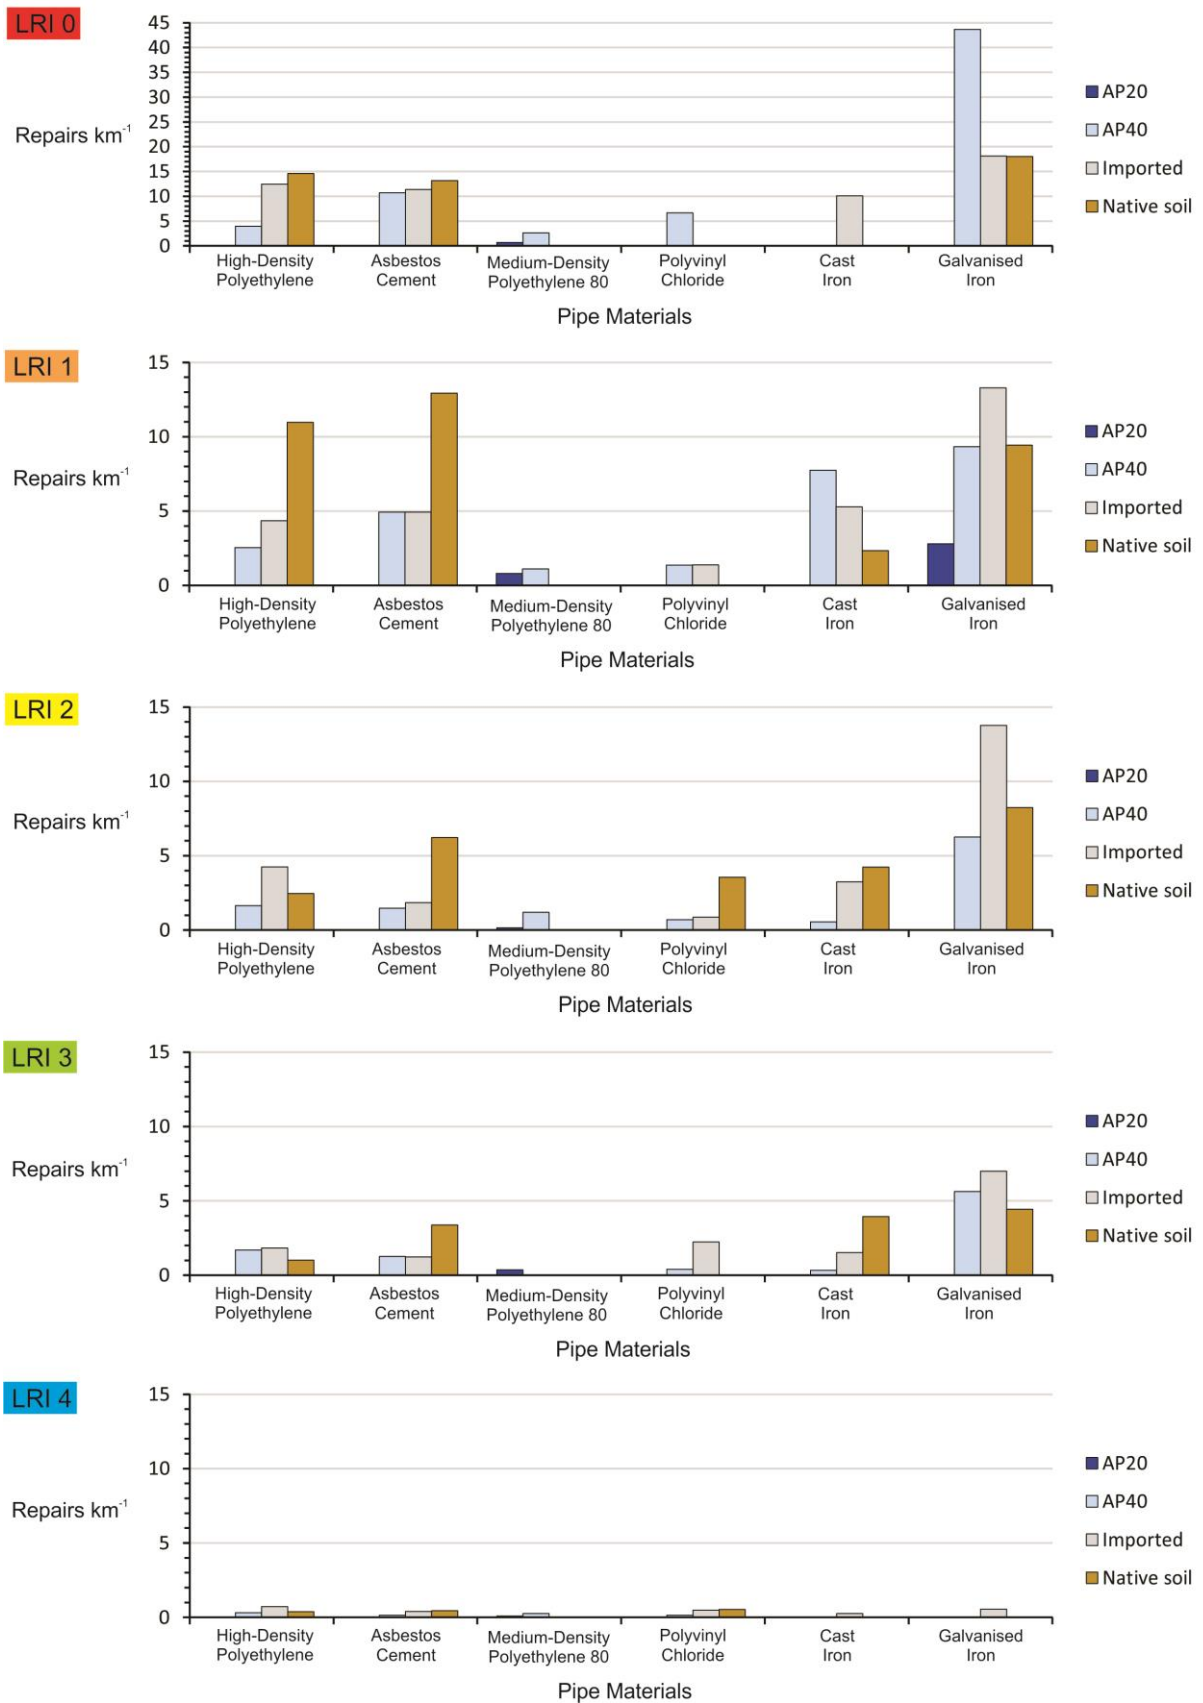
With these caveats in mind, some trends are evident in the trench data (Figure 18). For AC pipes in LRI Zones 0-3, repair rates are consistently higher in native soil backfills then for imported gravels or AP40 mix. HDPE repair rates are also highest in native soils in LRI Zones 0 and 1, but in LRI Zones 2 and 3 repair rates are lower in native soils than for imported gravels and AP40 mix. GI pipe repairs per km in LRI Zone 0 are highest in AP40 mix, and significantly lower for imported gravels and native soils, whereas for LRI Zones 1-3 the highest repair rates are in imported gravels backfill.

Figure 18. Pipe material repair rates for trench backfill characteristics within each LRI Zone.

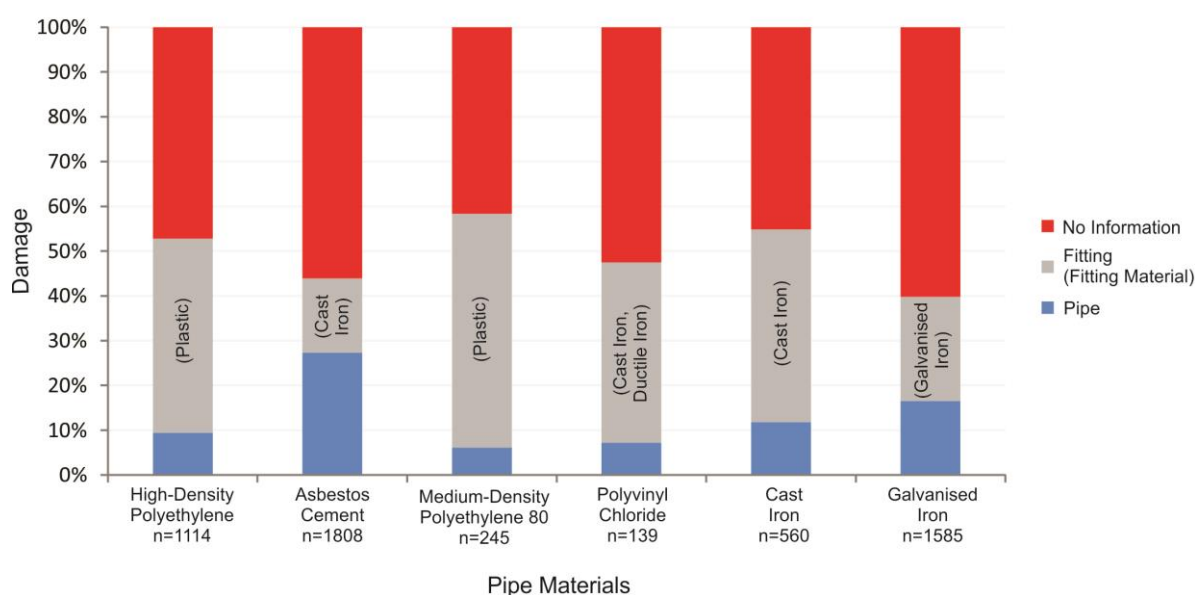
Definitions of damage categories are provided in Table 3, further details of failure modes are presented in Figure 20, and examples of pipe damage and fittings are presented in Figure 21 - Figure 32. As shown in Figure 20, for AC and GI pipe the dominant failures are to the pipe body, with circumferential and longitudinal splits relatively common for AC, and pinhole repairs relatively common for GI. For the remainder of pipe materials most failures were to fittings, with damage to property connection, coupler and gibaults most common.

Figure 19. Major damage categories for different pipe materials through the CES over the period 4 September 2010 to 30 June 2012. The dominant fitting materials used for each pipe material are noted in parentheses.

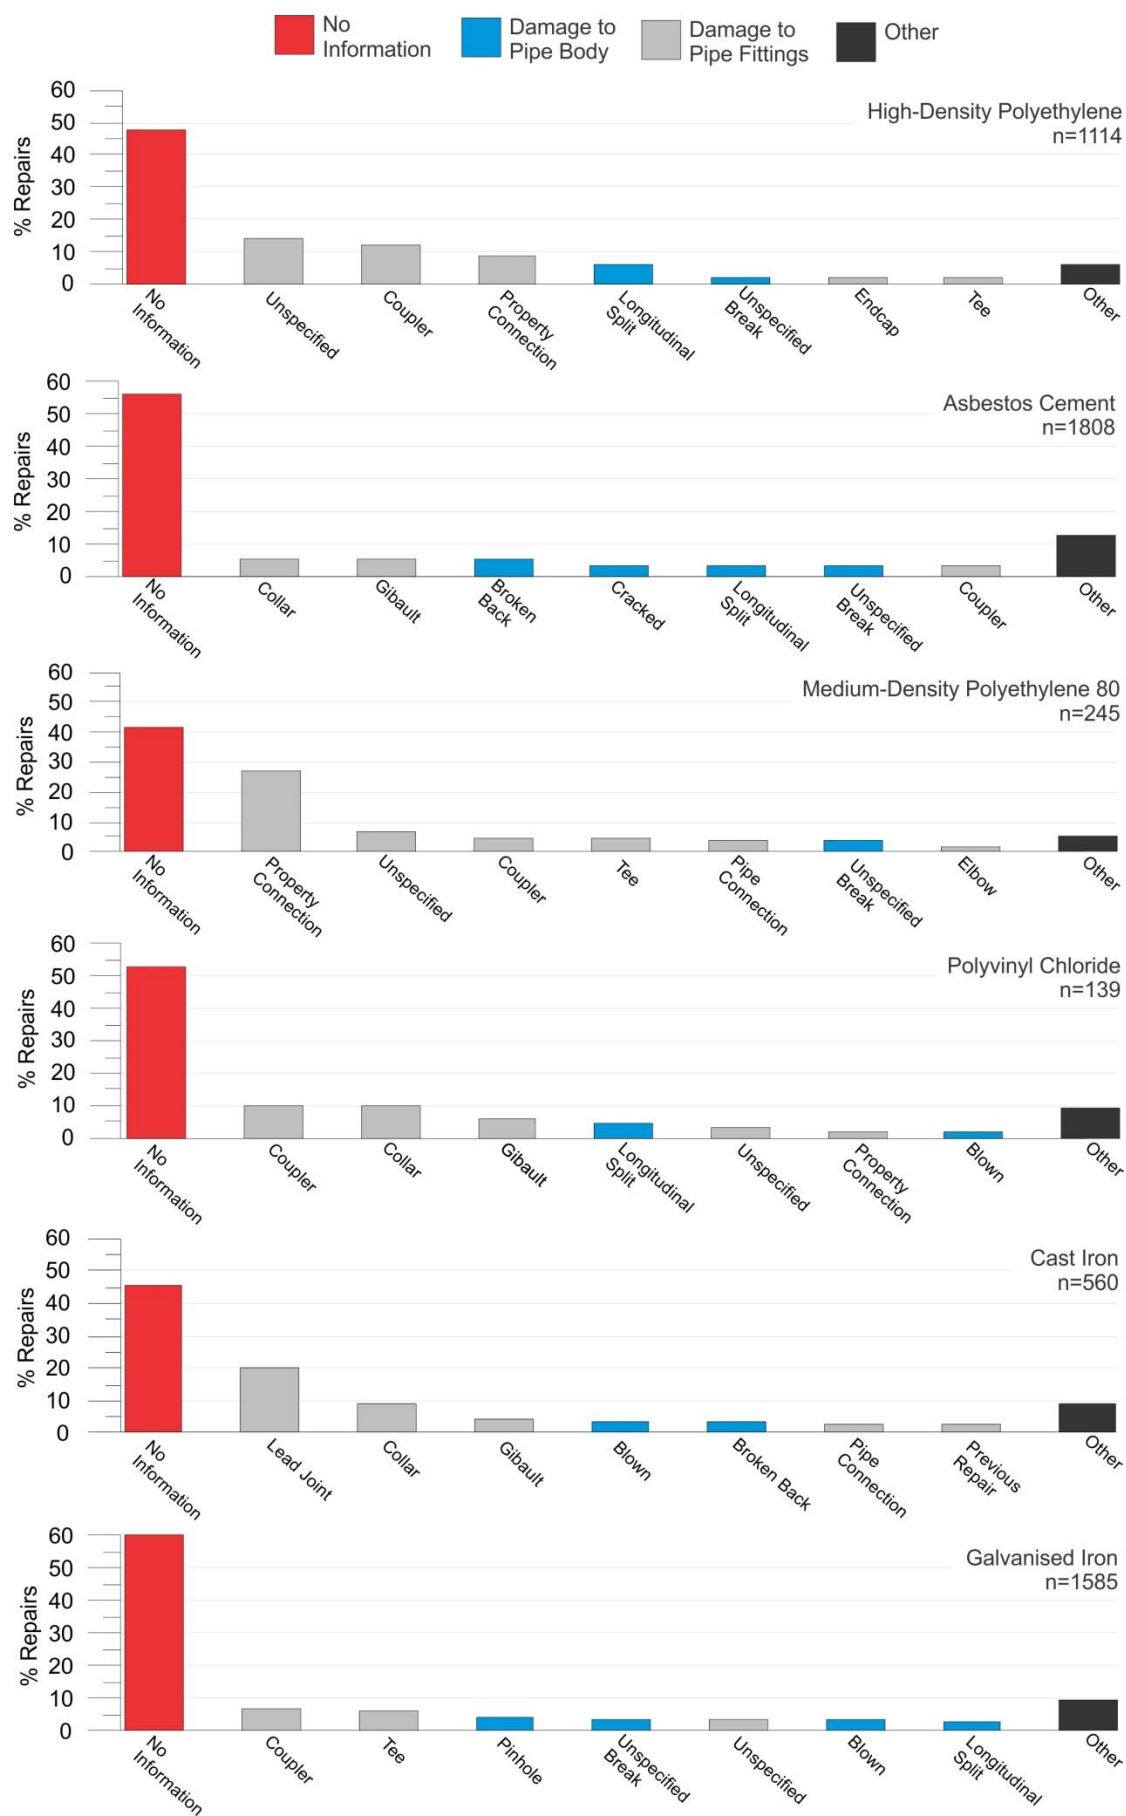
Figure 20. Failure modes for major potable water pipe materials for the period 4 September 2010 to 30 June 2012. Further details are presented in Appendix G.

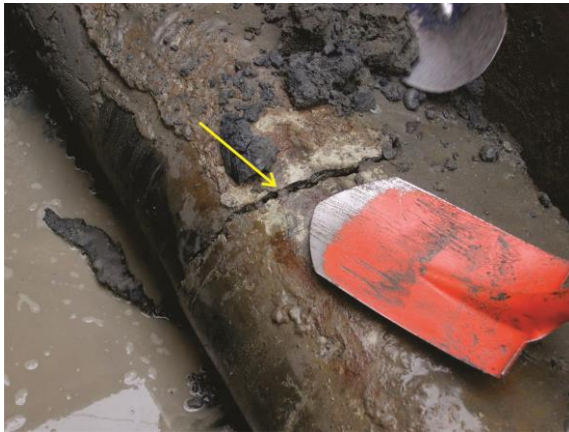
Figure 21. Circumferential split (indicated) on AC main, Rowan Avenue. Photo: Courtesy of Hugh Blake-Manson, CCL.

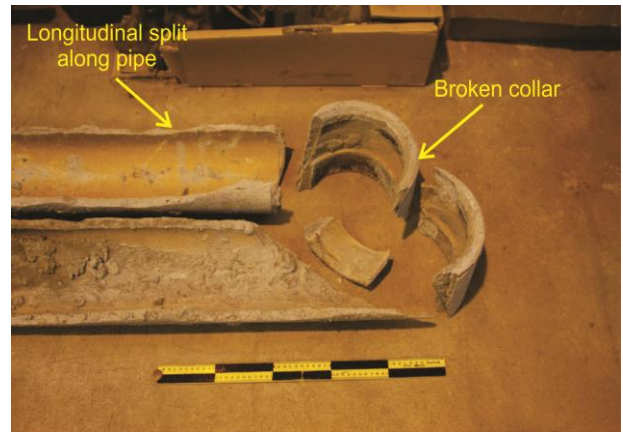
Figure 22. AC main broken collar and longitudinal split. Photo: M. Hughes.

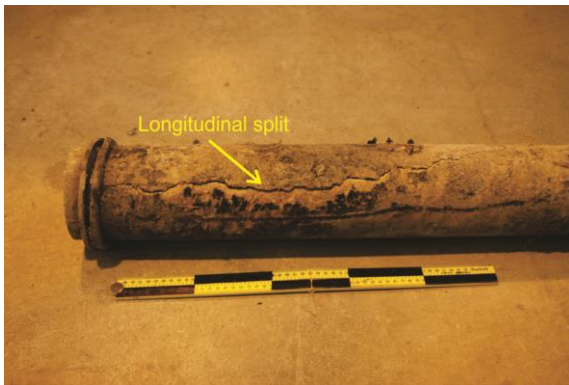
Figure 23. Longitudinal split on AC main. Photo: M. Hughes.

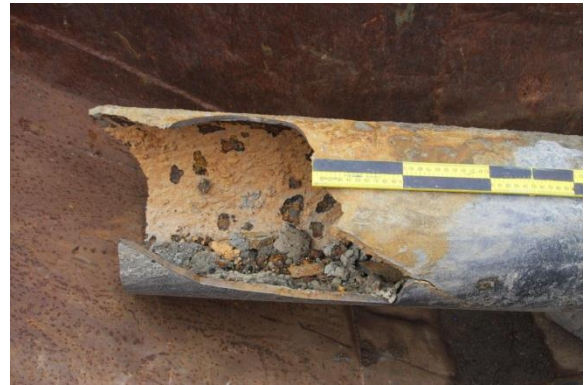
Figure 24. Broken CI main. Photo: M. Hughes.

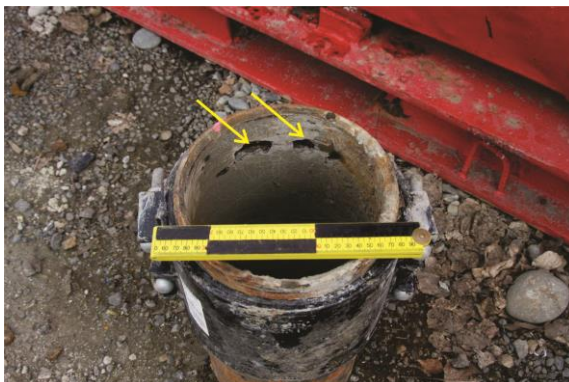
Figure 25. Bursts in the wall (indicated) of a CLS main. Photo: M. Hughes.
